LIMITED INDOOR ENVIRONMENTAL EVALUATION

MIAMI FEDERAL DETENTION CENTER

**33 NE 4TH STREET
MIAMI, FL 33132**

October 2009

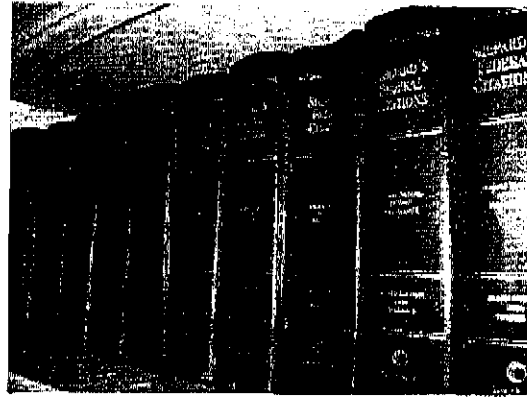
SVM on book bindings in Law Library

- a. Micro-clean all surfaces to remove mold from surfaces. Each surface should be HEPA vacuumed followed by damp wiping with a mild cleaning solution. The SVM appeared to be superficial and easily cleaned using the proper techniques. Porous items unable to be cleaned should be disposed of and replaced.
- b. A Mold and Water Damage Remediation Protocol and Site Specific Work Plan should be followed to ensure successful cleaning efforts.
- c. Eco Advisors can draft the Protocol and Work Plan and confirm the effectiveness of the remediation by collecting surface and air samples.
- d. Future housekeeping efforts should include hard to reach areas to prevent dust reservoirs, a common source of indoor irritants.
